# IMPACT RESISTANCE OF COMPOSITE FAN BLADES

GENERAL ELECTRIC COMPANY AIRCRAFT ENGINE GROUP Cincinnati, Ohio 45215

NATIONAL AERONAUTICS AND SPACE ADMINISTRATION
NASA-LEWIS RESEARCH CENTER

•	
1. Report No. NASA CR-134707	2. Government Access	sion No.	3. Recipient's Catalog No.
4. Title and Subtitle	, , , , , , , , , , , , , , , , , , , ,	<u></u>	5. Report Date
IMPACT RESISTANCE OF COMPO	SITE FAN BLADES	•	December 1974

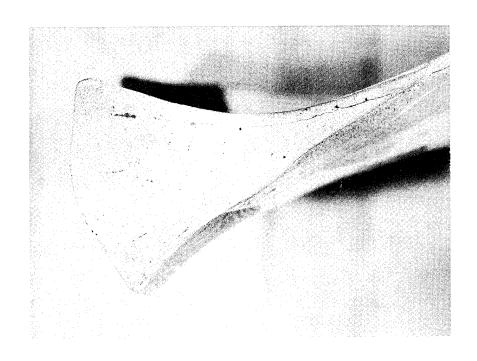
Figure 24. Dye Penetrant Inspection of Dovetail Leading Edge After Impact, Blade S/N NB1.

- S/N NB1 (gravel, iceballs) Crack along LE protection. Delamination area at base of the blade after impact (Figure 23). Dye penetrant inspection of the dovetail revealed a crack along the LE (Figure 24). Reduced velocity values at base of blade also indicate delamination.
- S/N NB2 [340 g (12oz) RTV bird, Figure 25] LE delamination at base concave side. Delamination at base of blade after impact.

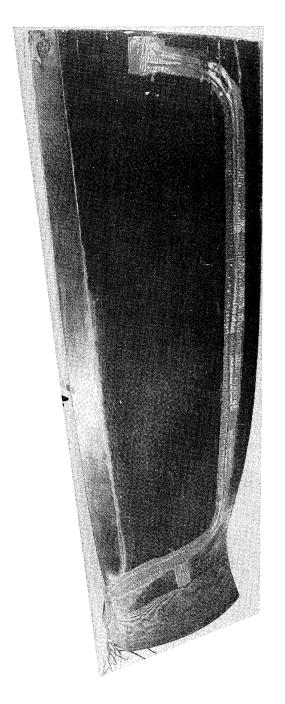
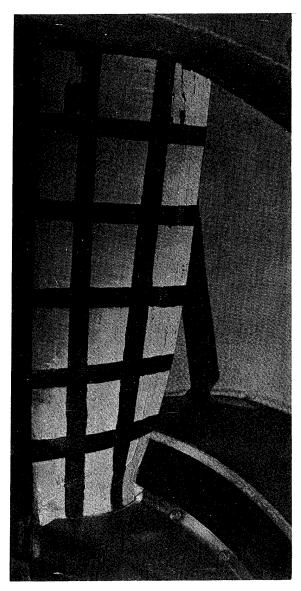
Figure 25. Blade S/N NB2 after Impact.

•	•
Blade S/N	Bird Size	Bite Size	Visual Damage
NGT	340 g (12 oz) Simulated Bird	170 g (6 oz)	Loss of sliver and delamination at trailing edge of blade tip. Crack in dovetail.
NB2	340 g (12 oz) Simulated Bird	170 g (6 oz)	Radial crack in tip. Very small crack in dovetail at leading edge.
NG3	794 g (28 oz) Simulated Bird	340 g (12 oz)	Blade broke off at root.
NB4	794 g (28 oz) Simulated Bird	340 g (12 oz)	Blade broke off at root.
NG4	454 g (16 oz) Real Pigeon	312 g (11 oz)	Crack in root, as indicated by dye penetrant. Delamination in tip area.
NB3	454 g (16 oz) Real Pigeon	283 g (10 oz)	Delamination at base of leading edge, piece out of tip at leading edge. Delamination across tip.
Ti	454 g (16 oz) Real Pigeon	227 g (8 oz)	No damage,

NASA-FOD Impact Resistance Test
Blade S/N NB2
Boron/Epoxy
Tip Speed: 244 m/sec (800 ft/sec)
340 g (12 oz) RTV Bird
170 g (6 oz) Slice
0.384 Radians (22°) Incidence Angle

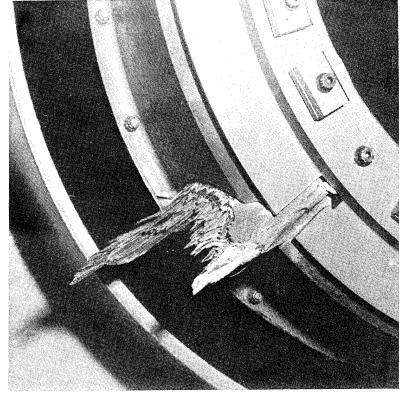
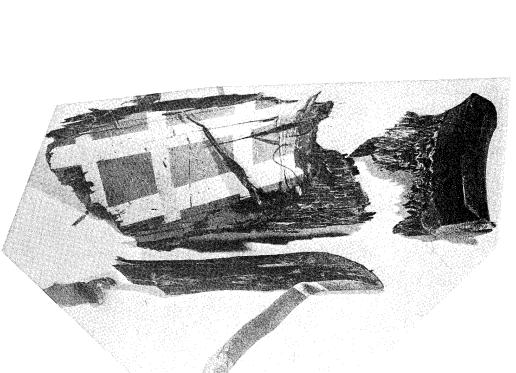
NASA-FOD Impact Resitance Test
Blade S/N NB4
Boron/Epoxy
Tip Speed: 244 m/sec (800 ft/sec)
794 g (28 oz) RTV Bird
340 g (12 oz) Slice
0.384 Radians (22°) Incidence Angle

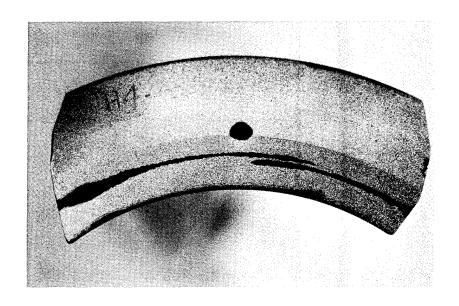
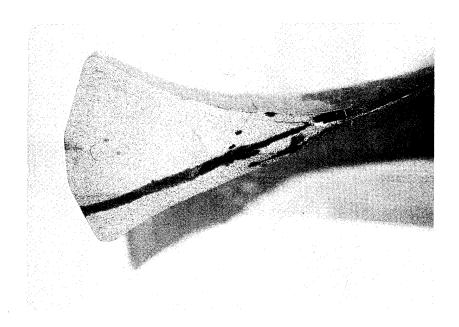
Figure 32. Dye Penetrant Inspection of Dovetail After Impact, Blade S/N NG1.

- S/N NG1 [340 g (12 oz) RTV bird, Figure 30] Crack in dovetail, slight separation of nickel from LE. TTUCS revealed delamination area at base plus damage at TE tip (Figure 31). Delamination in dovetail can be seen in photographs of dye penetrant check (Figure 32). Low velocity measurements were recorded at base of blade, TE side, indicating internal damage.

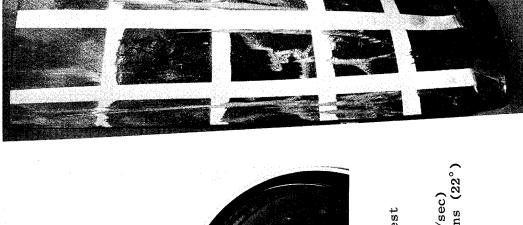
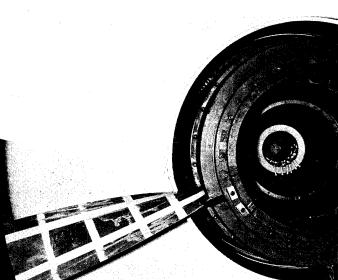
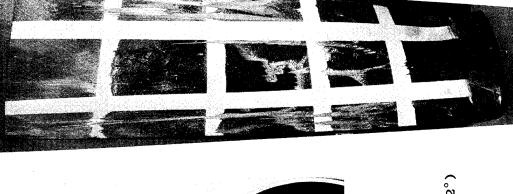
Incidence Angle: 0.384 Radians (22°) Tip Speed: 244 m/sec (800 ft/sec) NASA-FOD Impact Resistance Test Graphite/Epoxy Blade S/N NG2

N/S	Condition	Visual Damage
NG2	Gravel 0.38 cm (0.15") to 0.88 cm (0.38") Diameter Total Weight - 20 g (0.7 oz)	No visible damage.
NG2	Hailstones; Tempered Three, 5.08 cm (2") Diameter	No visible damage.
NB1	Gravel 0.38 cm (0.15") to 1.02 cm (0.25") Diameter  Total Weight - 20 g	No visible damage.
NB1	Hailstones; Tempered Three, 5.08 cm (2") Diameter	Slight crack at trailing edge tip, large crack 15.24 cm (6") long at leading edge metal plating.

Following Impact with Gravel, 0.38 to 0.88 20 grams Stones and cm Diameter

Total Weight, 210 g (7.4 oz). 3 Each 5.08 cm Diameter Following Impact with Tempered Hailstones.

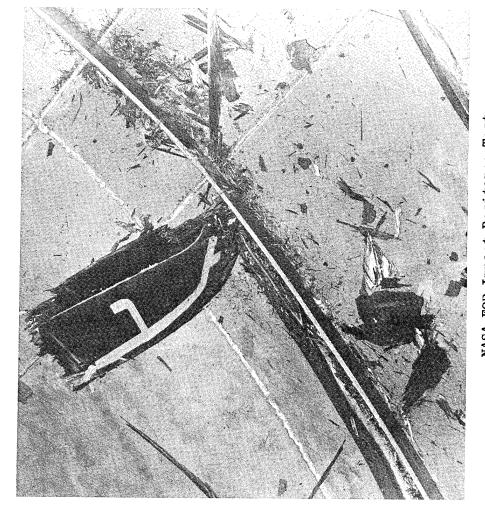
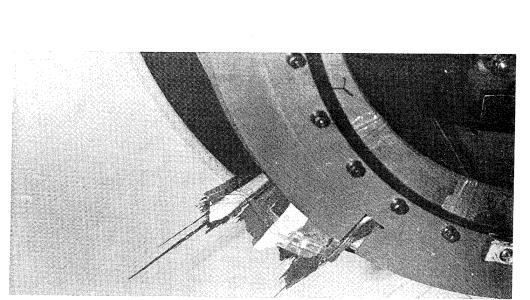
Figure 34. Blade S/N NG3 after Impact.

NASA-FOD Impact Resitance Test
Blade S/N NG3
Graphite/Epoxy
Tip Speed: 244 m/sec (800 ft/sec)
794 g (28 oz) RTV Bird
340 g (12 oz) Slice
0.384 Radians (22°) Incidence Angle

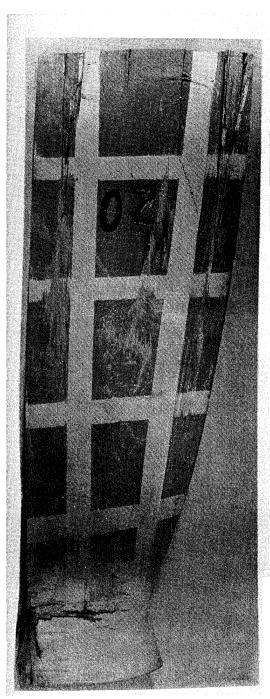
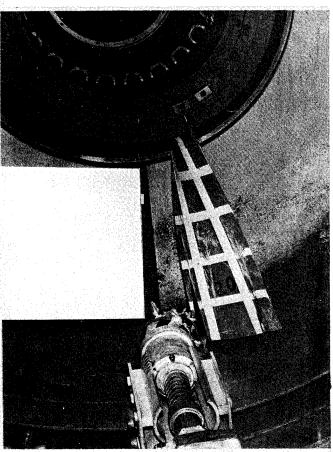
Figure 35. Blade S/N NG4 after Impact.

NASA-FOD Impact Resistance Test
Blade S/N NG4
Graphite/Epoxy
Tip Speed: 244 m/sec (800 ft/sec)
454 g (16 oz) Real Pigeon
312 g (11 oz) Slice
0.384 Radians (22°) Incidence Angle

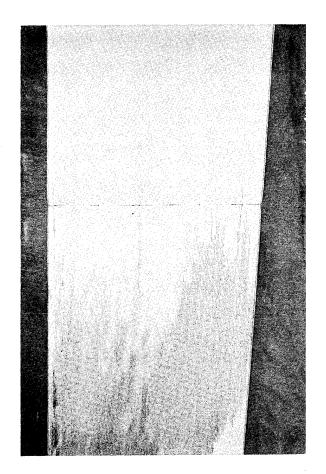
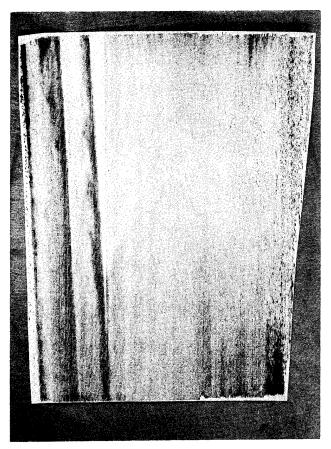
Figure 49. TTUCS of FOD Panel S/N 7, Before and After Impact.

Figures 46 through 50 show the TTUCS pictures of FOD specimens S/N 1 through S/N 8. C-scans, before test, were not obtained on specimens S/N 4, S/N 5, and S/N 6 due to equipment problems at the time. After impact, C-scans are shown for specimens S/N 5, S/N 7 and S/N 8. All scans before test show acceptable levels of grayness. Specimens S/N 5, S/N 7, and S/N 8 all sustained hits by an 85 g (3-oz) bird followed by a 227 g (8-oz) bird. Figure 48 shows S/N 5 after impact with an 85 g (3-oz) bird. Visual inspection revealed slight separation between the LE protection and the specimen at the tip. The specimen was not scanned after impact with the 227 g (8-oz) bird, which resulted in severe delamination and the LE being torn away. C-scans are shown for S/N 7 and S/N 8 after impact with the 227 g (8-oz) bird in Figures 49 and 50, respectively. Only moderate damage occurred to S/N 7 while S/N 8 had severe localized damage at the TE tip.

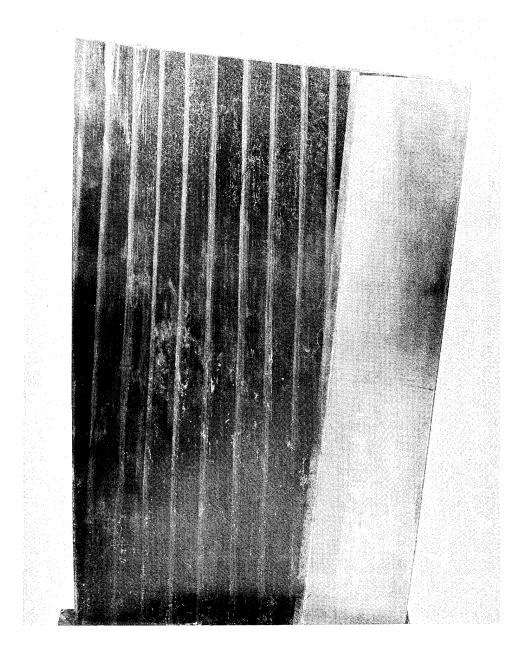
Figure 51. Panel S/N 2 After Impact.

NASA-FOD Program
Panel S/N 2
PR 288/80% AU/20% S-Glass
RTV Simulated Bird

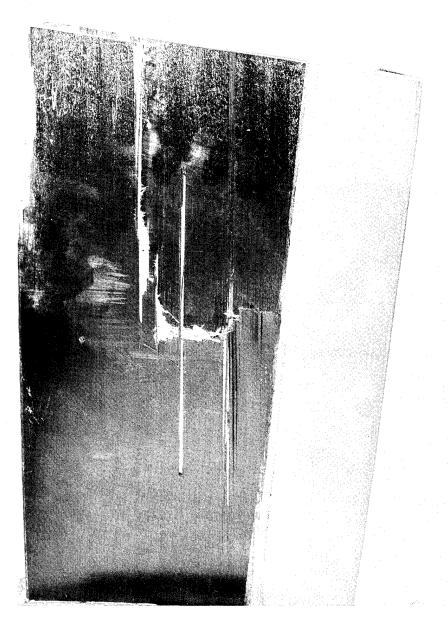
NASA-FOD Program Panel S/N 8 PR 288/AU with Kevlar 49 4 Plys @ ± 80° 4 Plys @ ± 45° At Tip RTV Simulated Bird

The most resistant material/lay-up configurations to the 227 g (8-oz) FOD were S/N 2 (Figure 51) and S/N 8 (Figure 52). The panels sustained moderate local damage but posttest investigation supported the selection of these panels as the best of those tested.

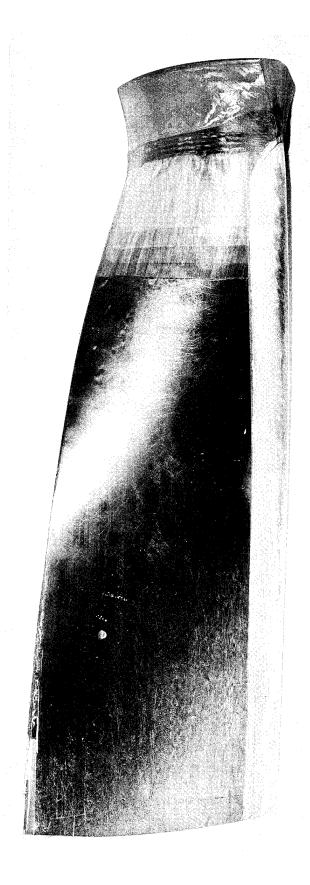
Figure 57. Blade S/N H/El After Impact.

NASA-FOD Program
Blade S/N H/E1
Design No. 2 Material/Lay-Up
RTV Simulated Bird
Bird Size: 794 g (28 oz)
Slice Size: 200 g (7 oz)
Blade Tip Speed: 244 m/sec (800 ft/sec)
Incidence Angle: 0.384 Radians (22°)

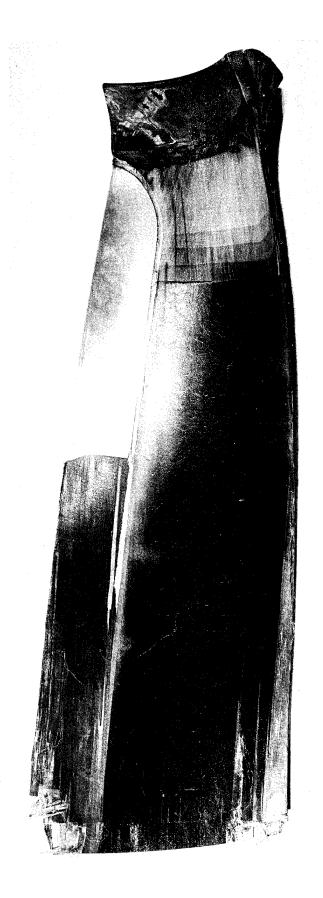
Figure 58. Blade S/N H/E2 After Impact.

NASA-FOD Program
Blade S/N H/E2
Design No. 2 Material/Lay-Up
RTV Simulated Bird
Bird Size: 1360 g (48 oz)
Slice Size: 680 g (24 oz)
Blade Tip Speed: 244 m/sec (800 ft/sec)
Incidence Angle: 0.384 Radians (22°)

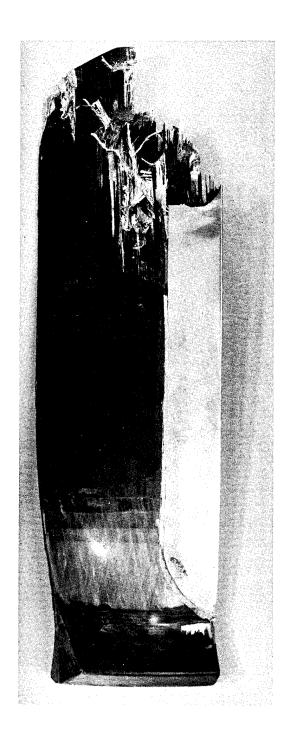
Figure 59. Blade S/N H/E3 After Impact.

NASA-FOD Program
Blade S/N H/E3
Design No. 2 Material
Real Mallard Duck
Bird Size: 1134 g (40 oz)

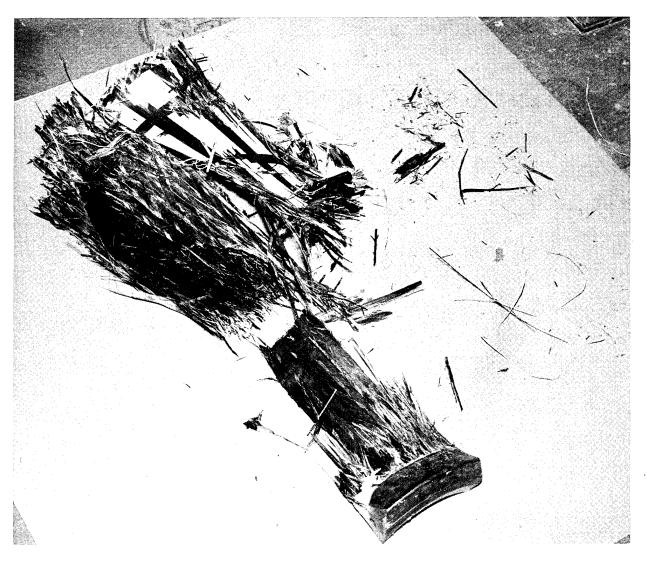
Figure 61. Blade S/N H/E5 After Impact.

- S/N H/E 5, H/E 6 Both H/E 5 and H/E 6 sustained 100% delamination after impact with 765 g (27-oz) and 567 g (20-oz) slices of birds, respectively. H/E 5 broke off at the root, while H/E 6 remained in one piece. Figure 67 shows these blades prior to test.

NASA-FOD Program
Blade S/N H/E5
Design No. 1 Material
RTV Simulated Bird
Bird Size: 1360 g (48 oz)
Slice Size: 765 g (27 oz)

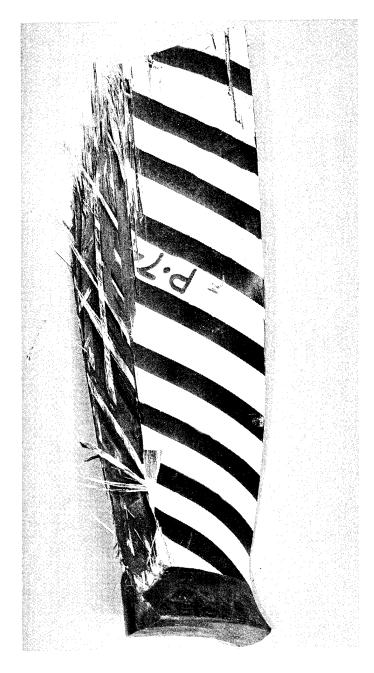
Figure 62. Blade S/N H/E6 After Impact.

NASA-FOD Program
Blade S/N H/E6
Design No. 1 Material
Real Mallard Duck
Bird Size: 1134 g (40 oz)
Slice Size: 570 g (20 oz)

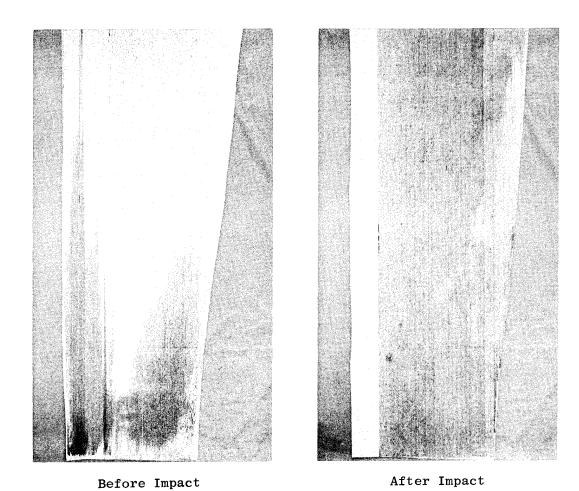
Figure 64. TTUCS of Hybrid/Epoxy Blade S/N H/E2.

- S/N H/E 2 Hybrid blade H/E 2 was impacted with a 680 g (24-oz) slice of a simulated bird. Figure 64 shows the TTUCS prior to and after impact. The entire LE protection system was torn off the blade. This appears as a white strip down the left edge on Figure 64. The airfoil was completely delaminated in addition to two cracks down in the dovetail.

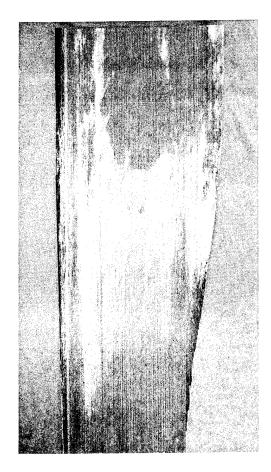
Figure 66. TTUCS of Hybrid/Epoxy Blade S/N H/E4.

- S/N H/E 4 H/E 4 suffered local tip delamination, LE protection separation, and a single crack in the dovetail after impact with an 227 g \*8-oz) slice of a simulated bird (Figure 66).
